SAMPLING ACTIVITIES/TRIP REPORT

COUNTY LINE MERCURY

Highlands Ranch, Douglas County, Colorado

TDD No. 9605-0006

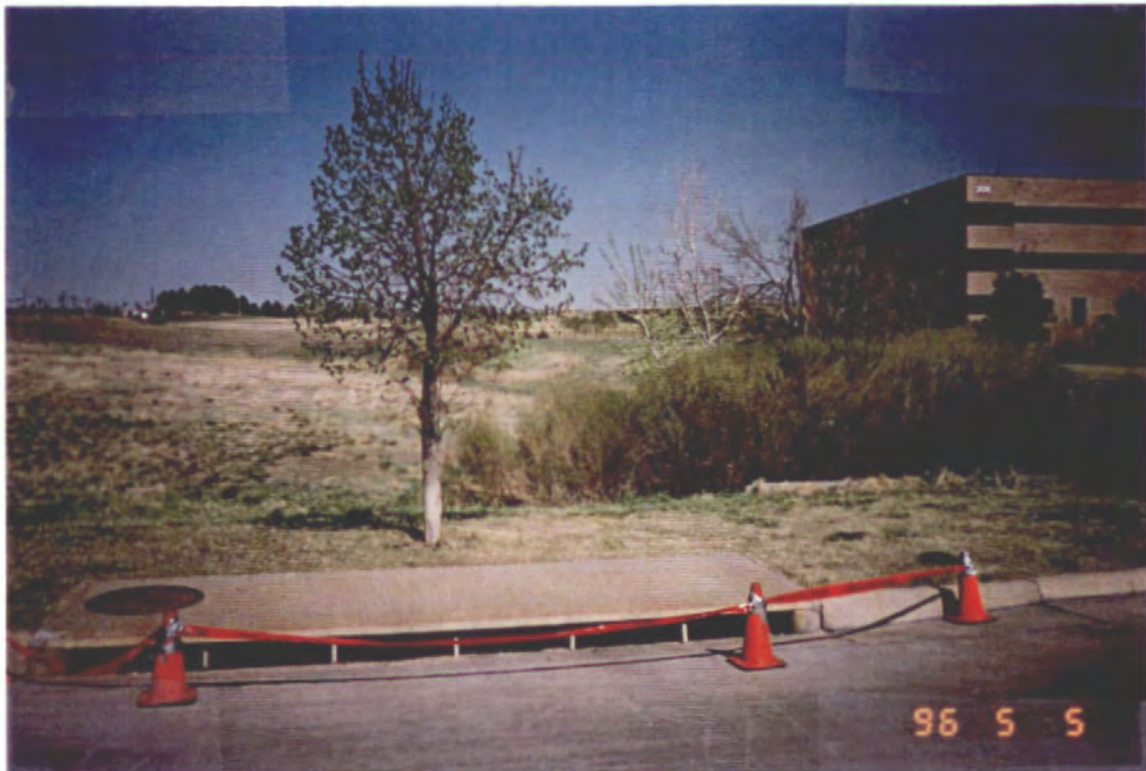
PHOTO 1

Storm sewer drain leading into storm sewer vault, looking east. The area is roped off due to mercury contamination.

On May 5, 1996, the URS Operating Services, Inc. (UOS) Superfund Technical Assessment and Response Team (START) personnel were mobilized to a residential mercury spill. Pete Stevenson was designated as the U.S. Environmental Protection Agency (EPA) On-Scene Coordinator (OSC). The County Line Mercury site is located on County Line Road at The Bluffs Complex, immediately west of South Broadway, Douglas County, Colorado (Photo 1) (Figure 1).

The original spill occurred during the week of April 28, 1996, when two adolescent males discovered approximately seven unlabeled vials containing mercury in a storm drain culvert (Photo 10). Approximately 7-9 pounds of elemental mercury was released into a culvert/storm drain, on the stair case leading up to Apartment 203 of Building 19 (Apt. 203), within two private residences (Apt. 203 and Apartment 103 of Building 16 (Apt. 103)), and on various patches of the lawn and sidewalk (Photos 1, 2, and 9).

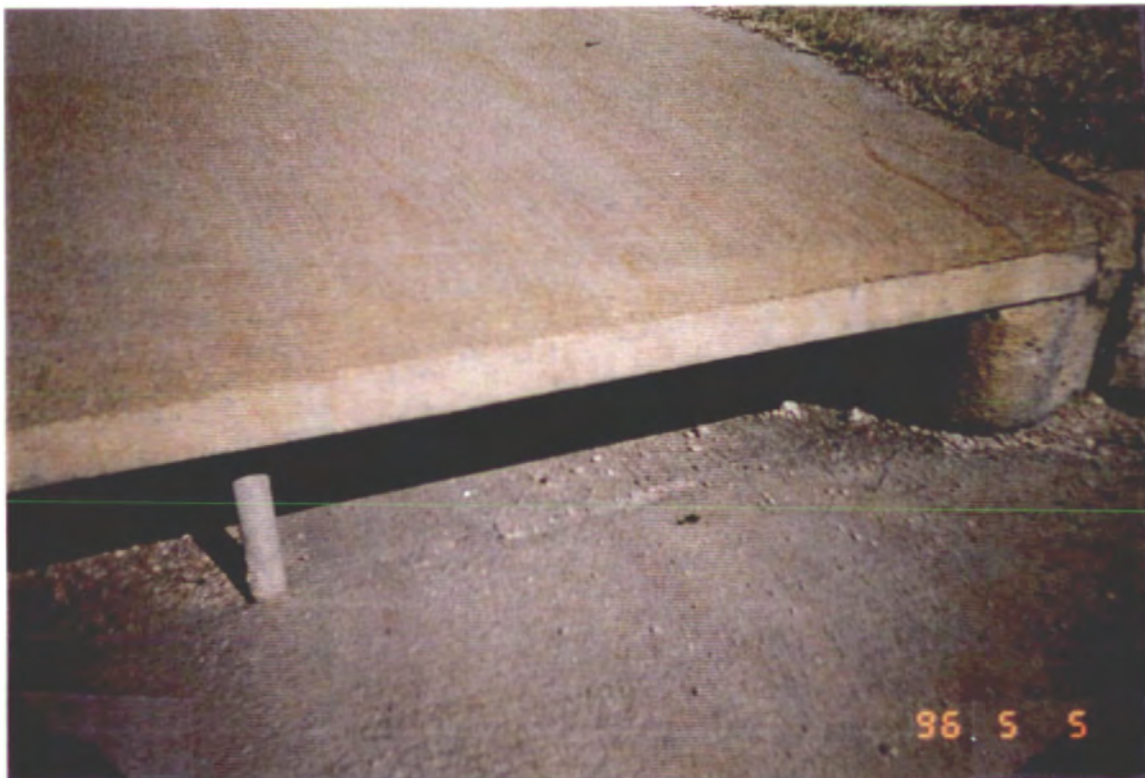
PHOTO 2

Close up of storm sewer drain with mercury beads present. Drain is located on the east side of the entrance into Bluffs Complex.

Small beads of mercury were noticed in the storm sewer vault, concrete stairway, and lawn adjacent to the concrete stairs (Photos 2 and 5). The concrete staircase for Building 19, leading up to Apt. 203, was cleaned (Photo 9). The extent of mercury contamination was severe along the steps within a major crack of one step, in the surrounding grass, and in the woodchips to the

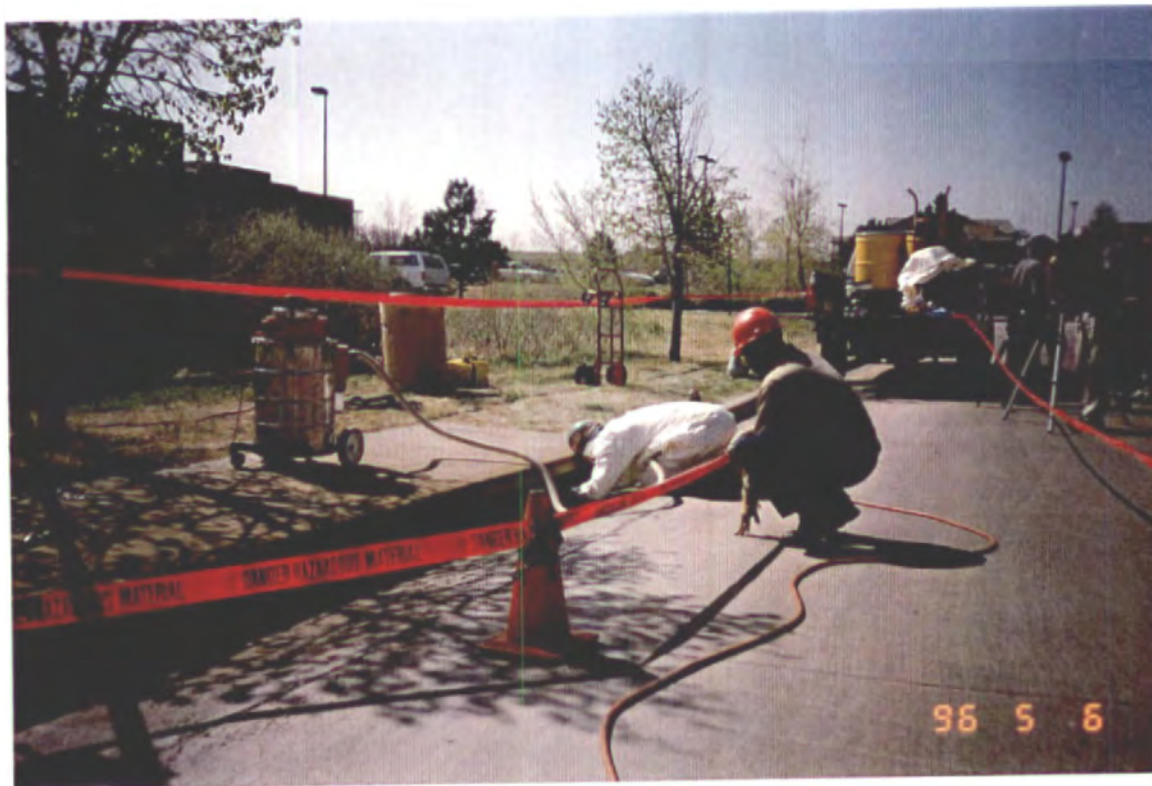
PHOTO 3

Smith/Riedel contractors cleaning up free mercury beads with a vacuum along the storm sewer drain.

In response to the release, the two residences, the concrete staircase, and the concrete storm drain were cleaned up by Smith/Riedel (Photos 3 and 4).

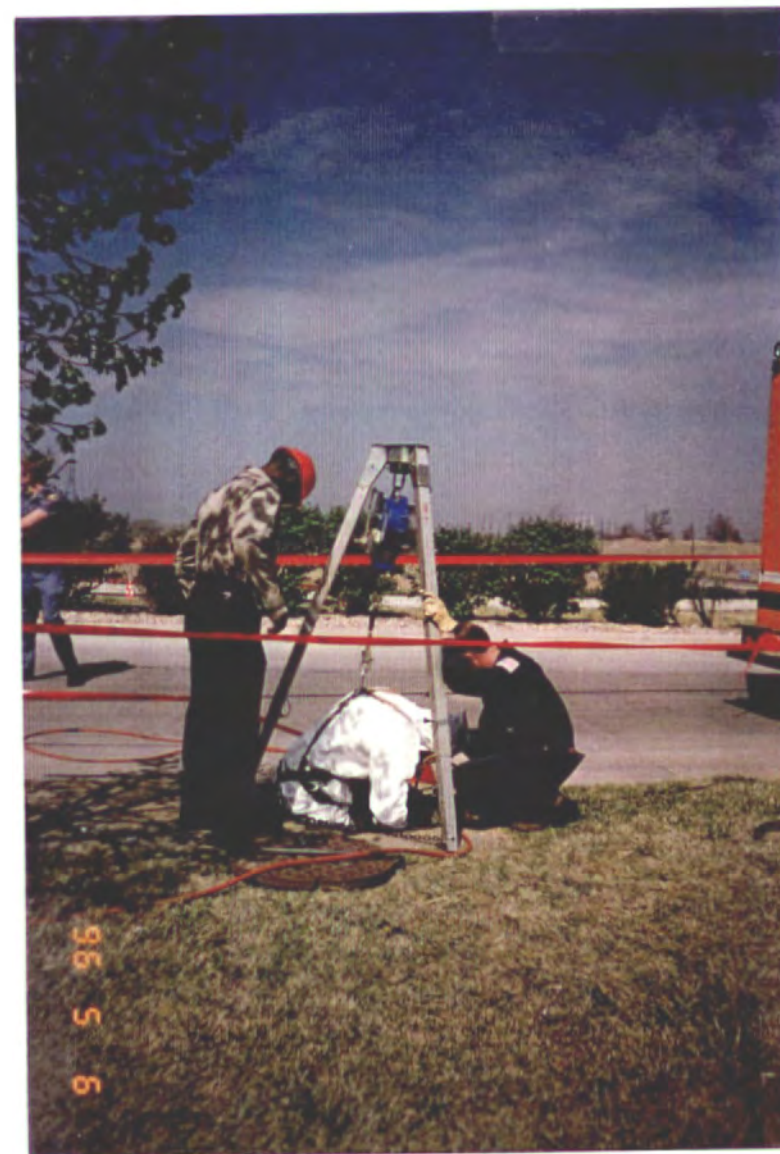
PHOTO 4

Smith/Riedel personnel performing a confined space entry into the storm sewer vault for cleanup of mercury contamination.

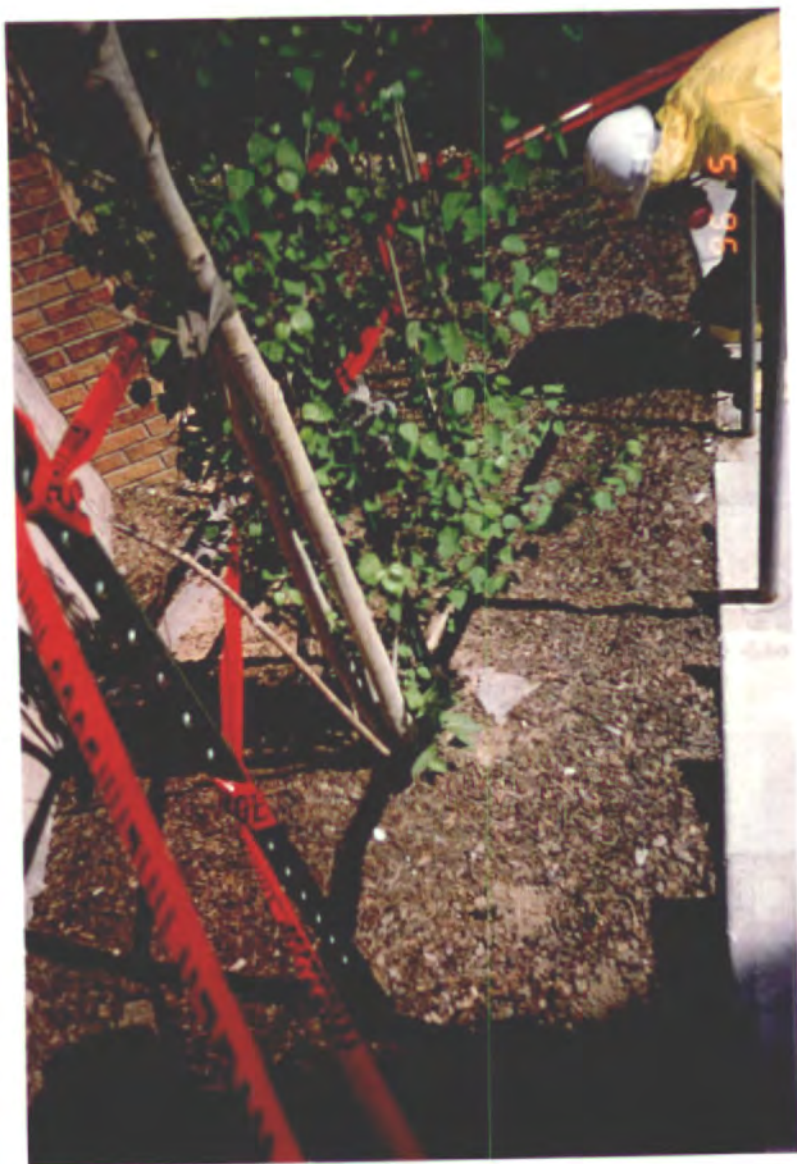
PHOTO 5

START personnel conducting preliminary air monitoring along woodchips near apartment No. 203 with a Jerome Mercury Vapor Analyzer.

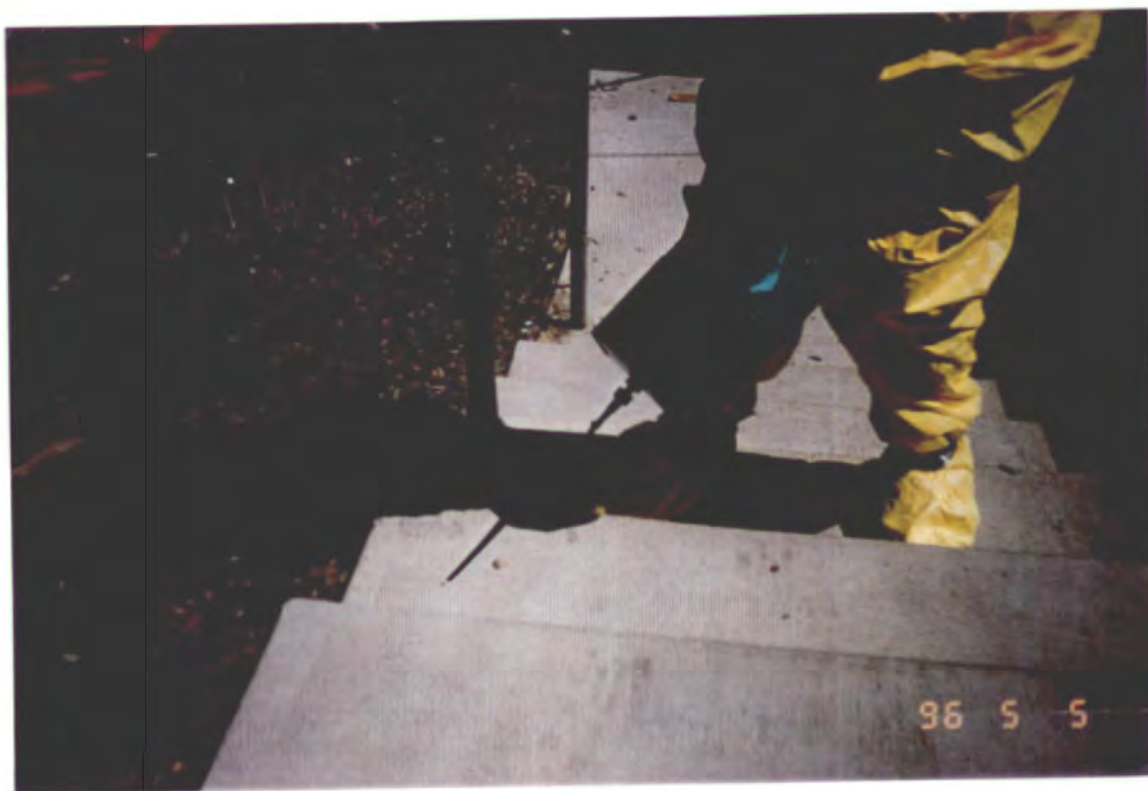
PHOTO 6

START personnel surveying mercury contamination along concrete steps leading to Apt. 203, Building 19, with Jerome Mercury Vapor Analyzer.

A Jerome Mercury Vapor Analyzer Model 431-X was used to screen the indoor air quality and ambient air quality within potentially contaminated areas (Photo 6). Mercury vapor concentrations were detected above the instrument detection limit of 0.0003 mg/m^3 ; therefore, EPA OSC, Pete Stevenson, requested more definitive air monitoring.

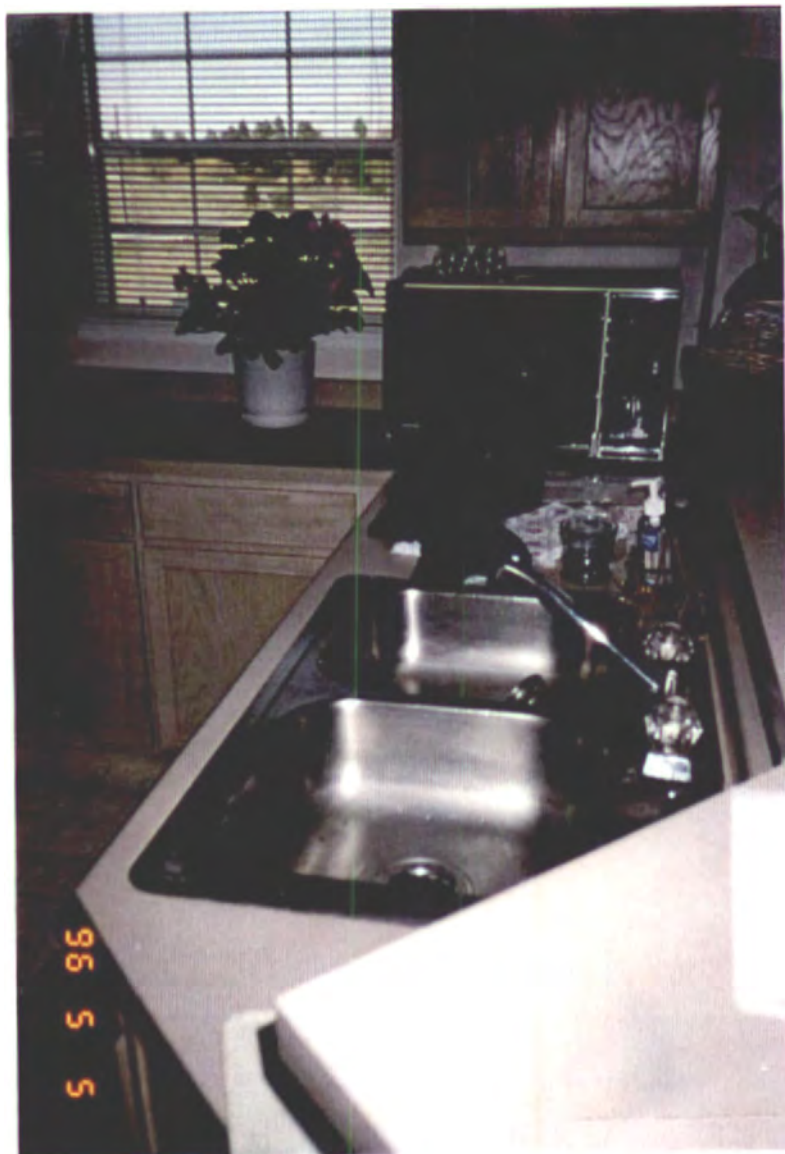
PHOTO 7

Kitchen in Apartment 203. Free standing mercury observed in sink, garbage disposal, and trap.

north of the steps (Photo 5). Beads of mercury were noted in the garbage disposal and sink in Apt. 203 (Photo 7).

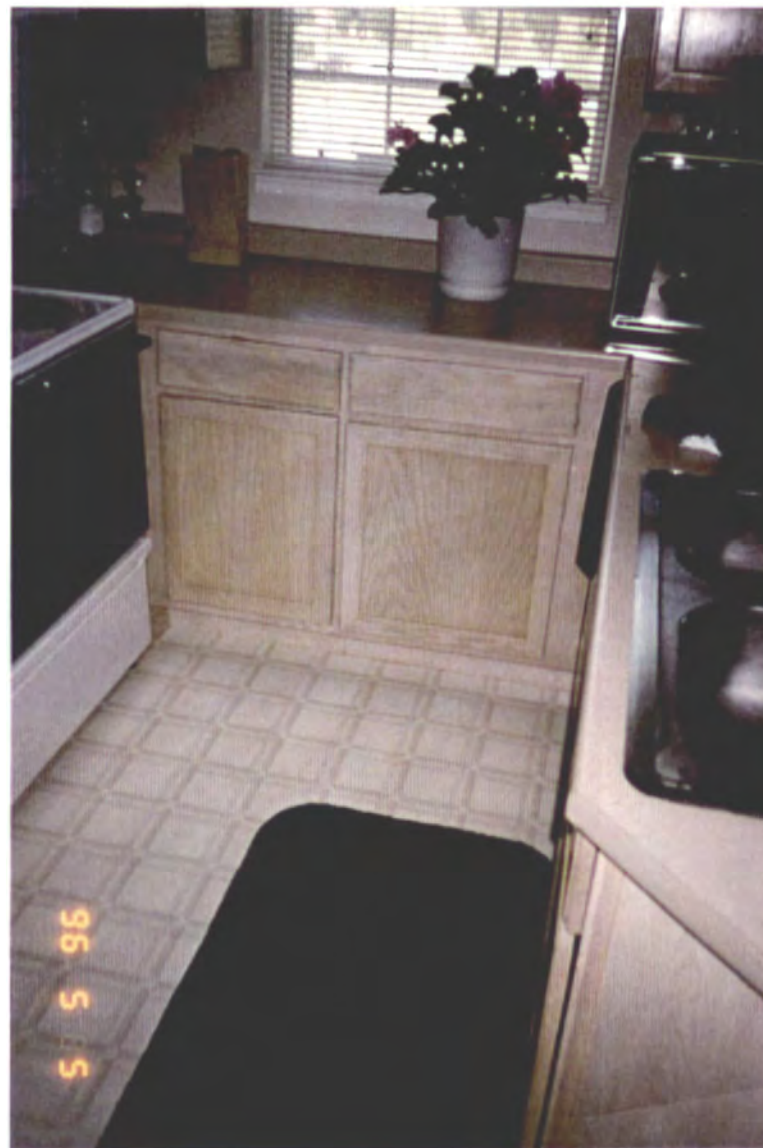
PHOTO 8

Kitchen of Apartment 203, Building 19.
Note: Apartment had been cleaned prior to survey.

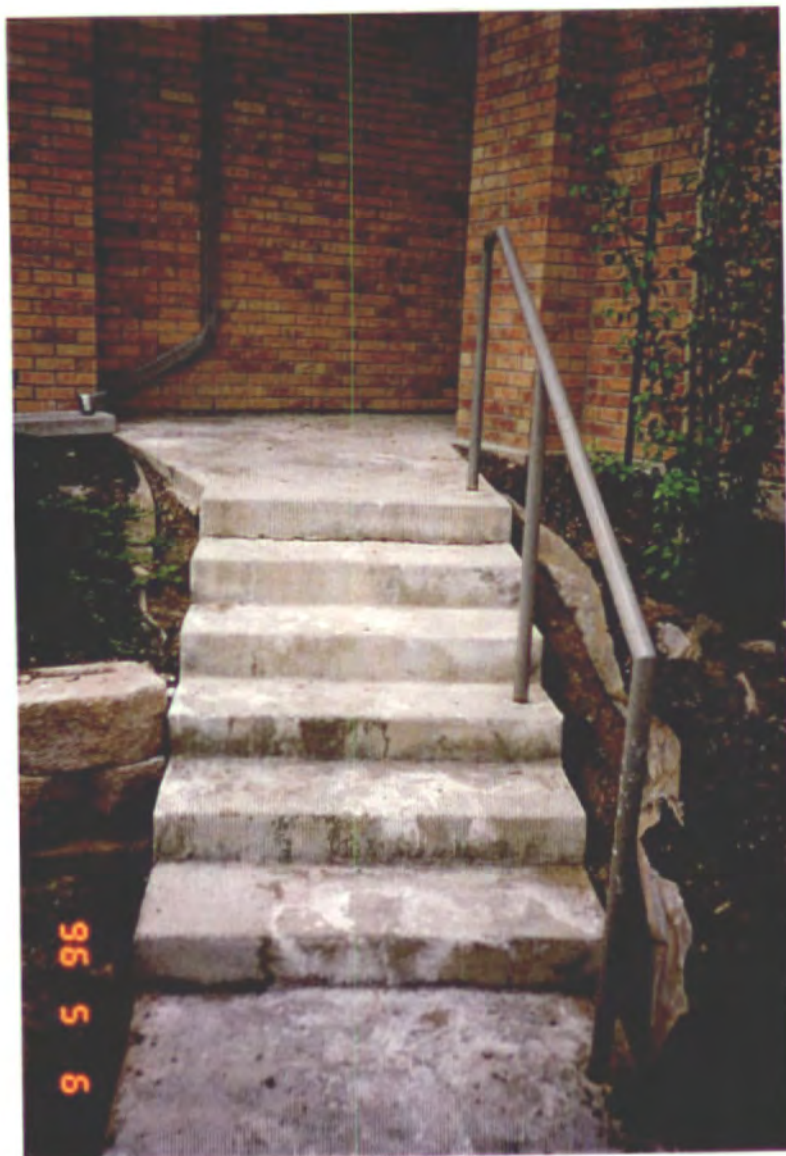
PHOTO 9

Concrete steps leading to Apt. 203 after mercury had been vacuumed. Major crack on top step contained most of the mercury. Woodchips/landscaping had extensive mercury contamination as well. Not all the mercury could be removed.

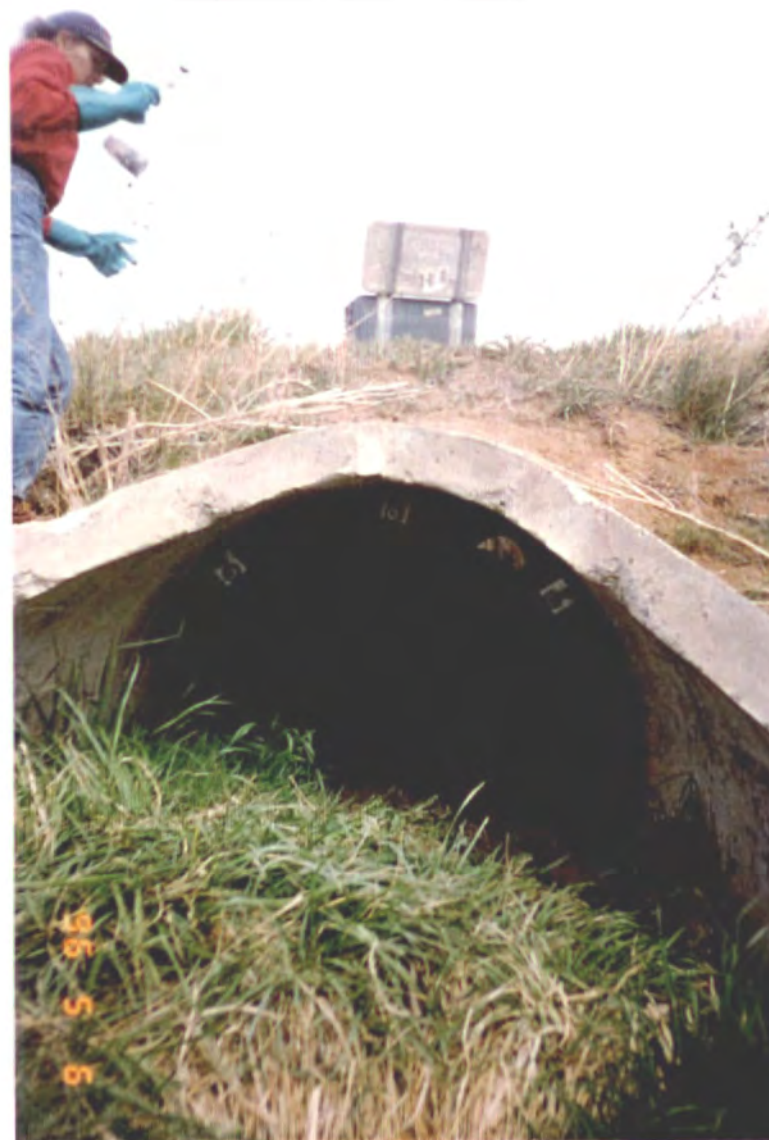
PHOTO 10

West end of culvert opening. Sample location CL-SE-01 inside edge of culvert. This is where adolescent males entered culvert which connects to vault (left side).

sample results (shown in Table 3) indicate a reduction in elemental mercury concentrations following cleanup efforts along the concrete stairs and within the storm sewer vault; CL-SO-01 decreased from 8.836 ppm to 0.985 ppm. The mercury concentration of the sediment samples taken from the west side of the culvert drainage were (CL-SE-01) 14.50 ppm and (CL-SO-13) 3.40 ppm after cleanup; sediment samples collected down gradient and outside of the actual culvert (CL-SE-02 and CL-SE-03) were at or below the laboratory's instrument detection limit of 0.1 ppb (Photos 10, 11, and 12) (Appendix B, Analytical Results).

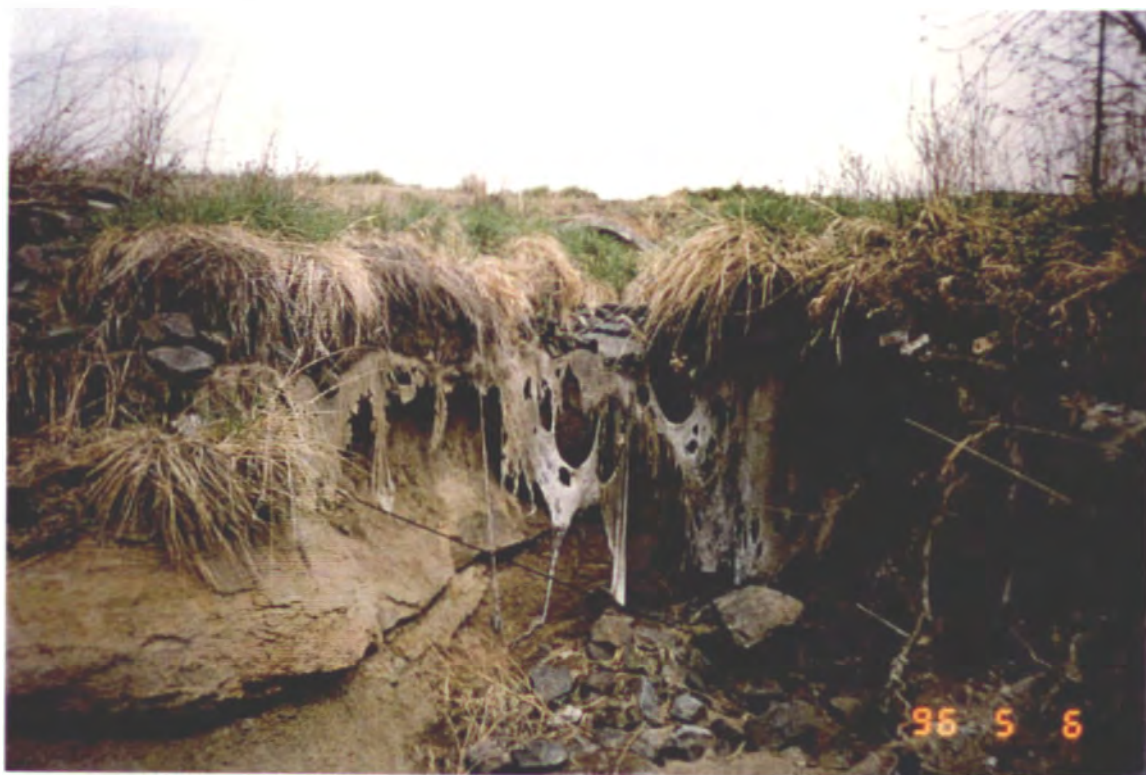
PHOTO 11

Sample location CL-SE-02; drainage channel from west end of culvert.

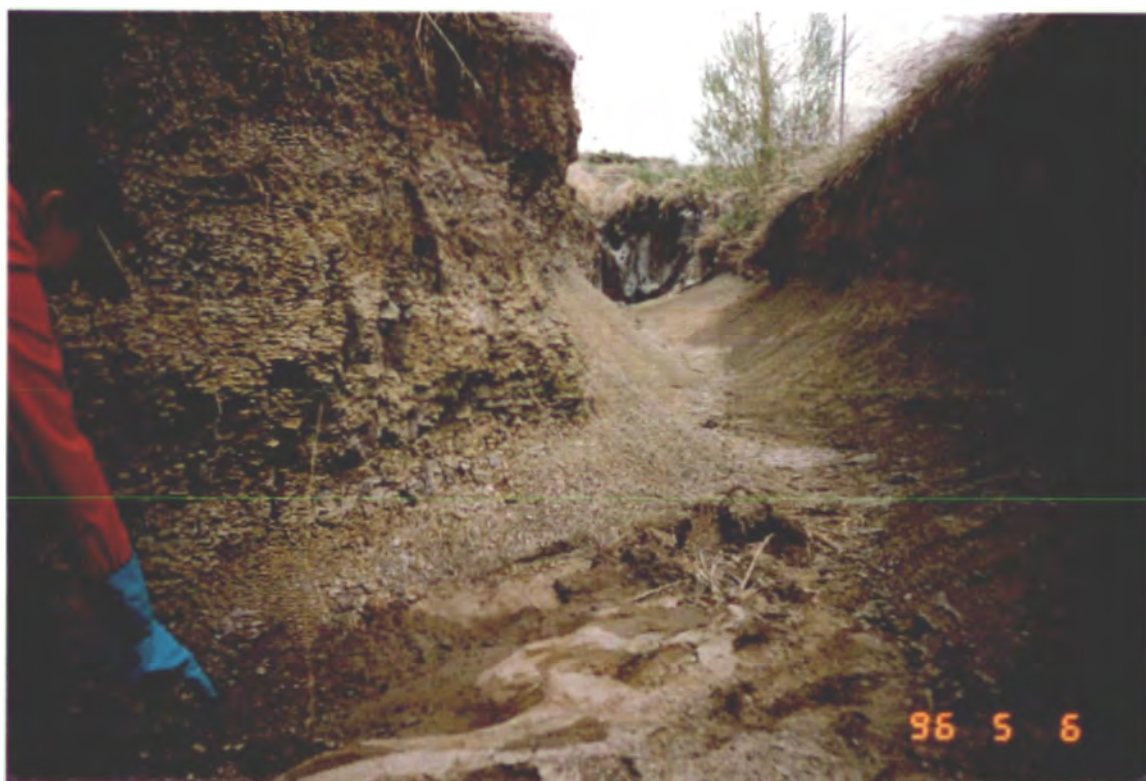
PHOTO 12

Sample location CL-SE-03; drainage ditch from west end of culvert.

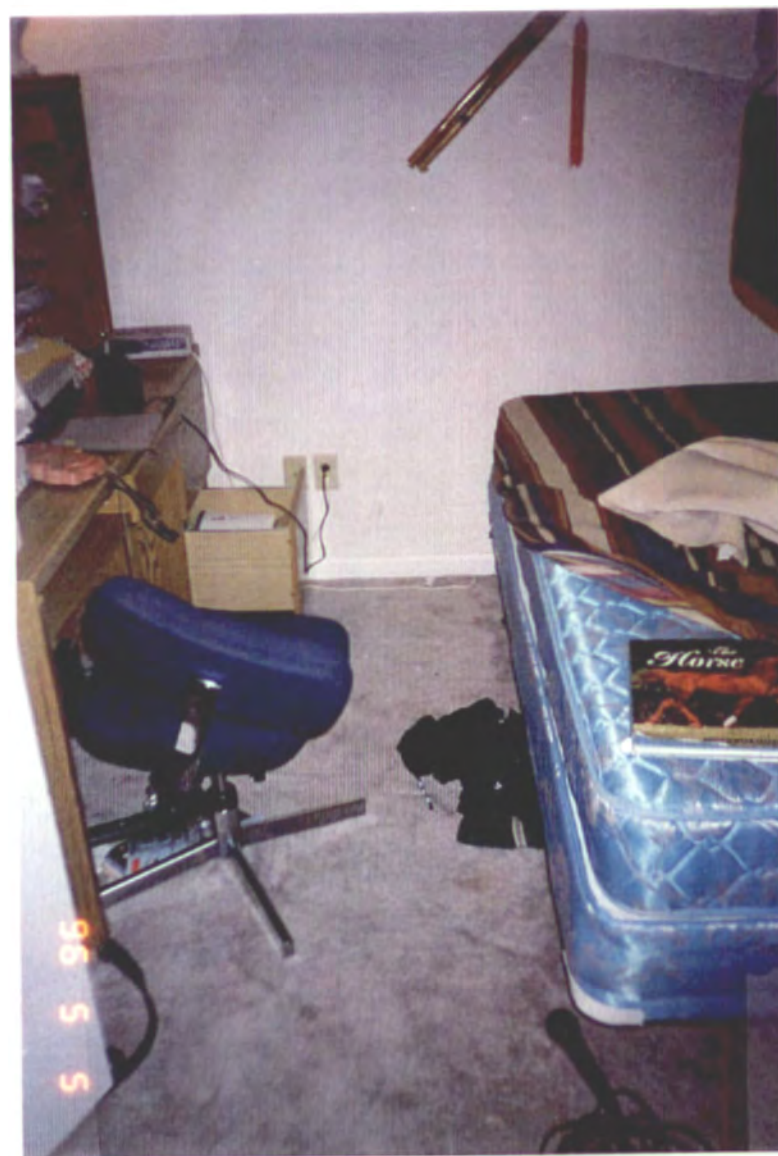
PHOTO 14

Apartment 103, bedroom of adolescent. Extensive mercury contamination on carpeting, desk, desk chair, bed, and clothing.

Apt. 103 appeared to have more significant contamination, as fine mercury beads were visible throughout the carpet. The adolescent's bedroom in Apartment 103 had extensive visual mercury contamination on the desk, chair, dresser, carpeting, and television (Photos 13, 14, and 15). Some small beads of mercury were located in the living room on the floor, coffee table, and couch.

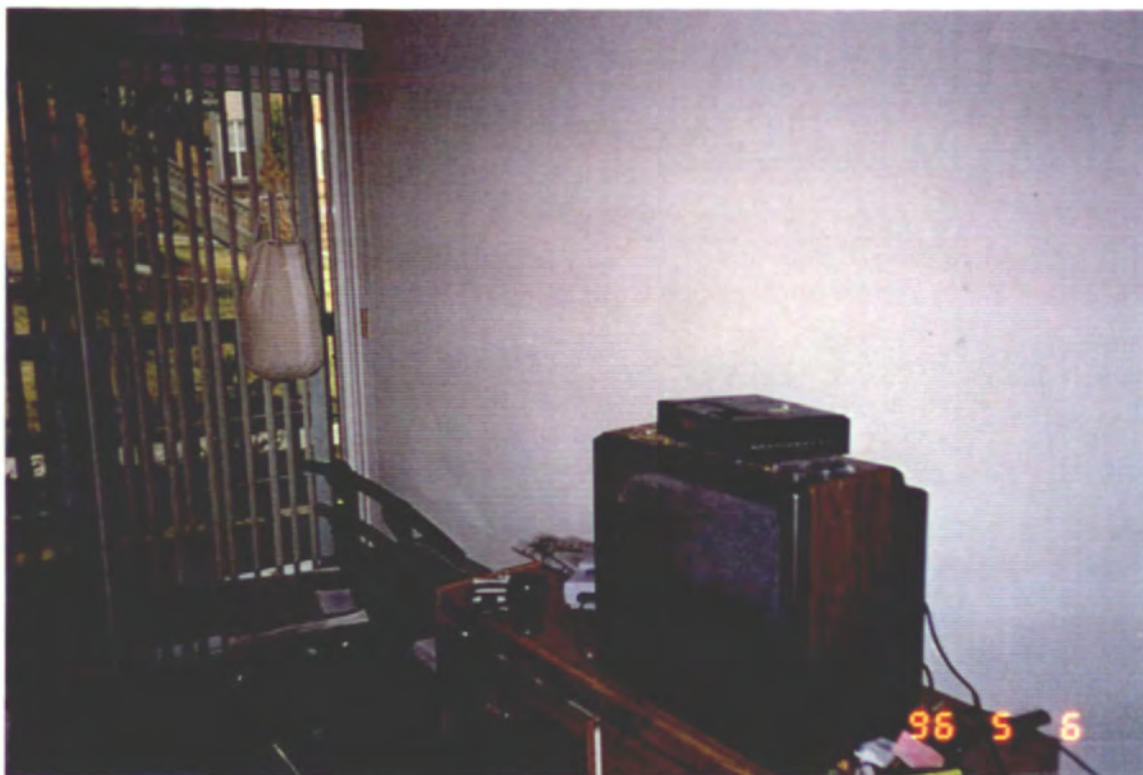
PHOTO 15

Bedroom of adolescent in Apt. 103. Mercury beads were found in some of the drawers in the dresser.

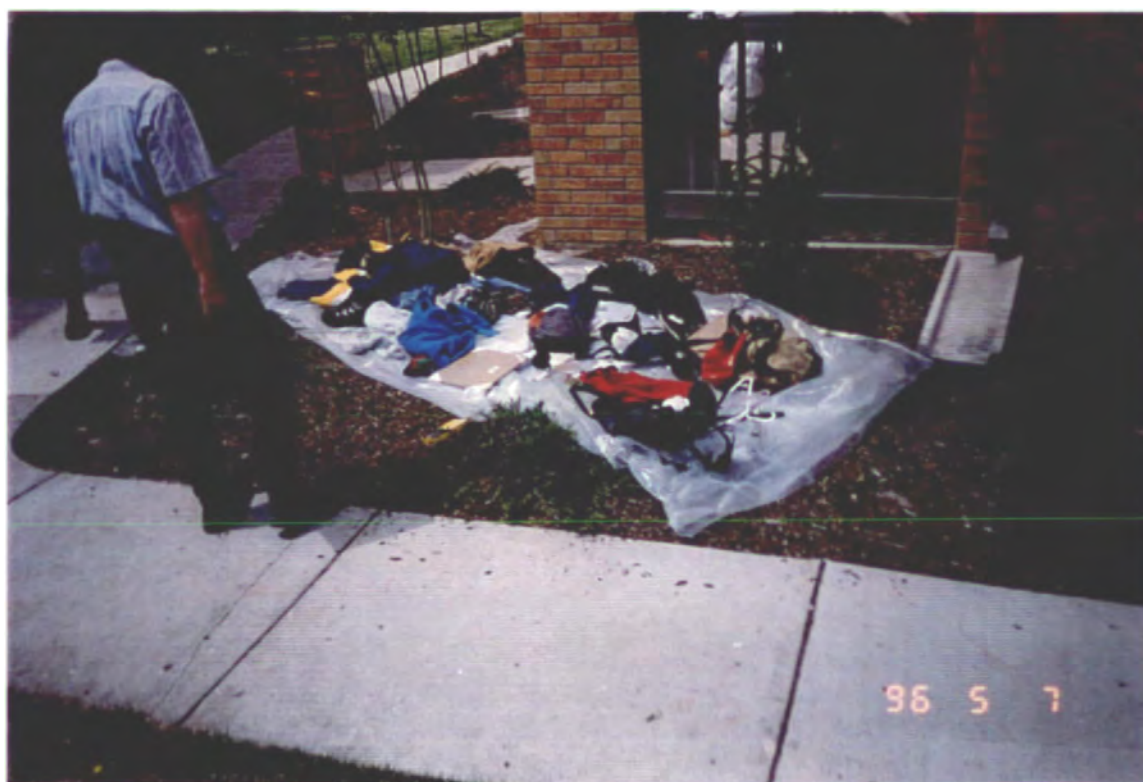
PHOTO 16

START personnel monitoring mercury vapor concentrations after belongings had been aired out in front of Apartment No. 103.

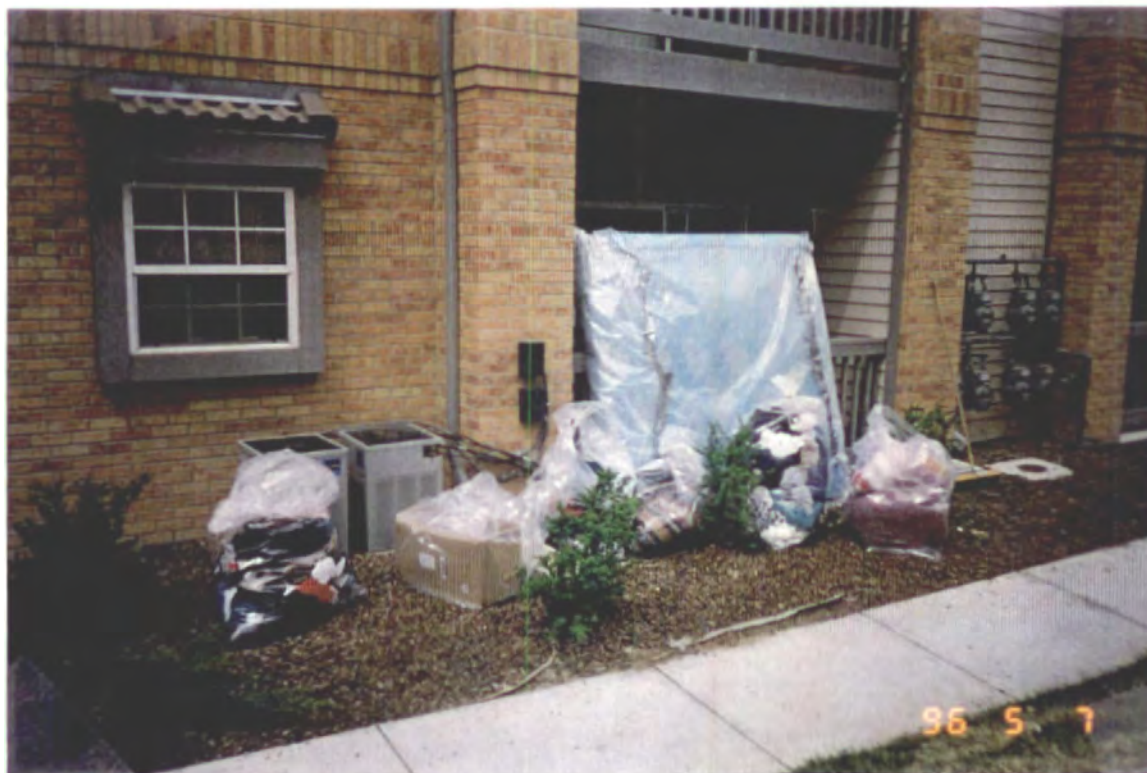
PHOTO 21

Bagged items from Apartment 103 for disposal after ventilation efforts were unsuccessful in lowering mercury vapor concentrations.

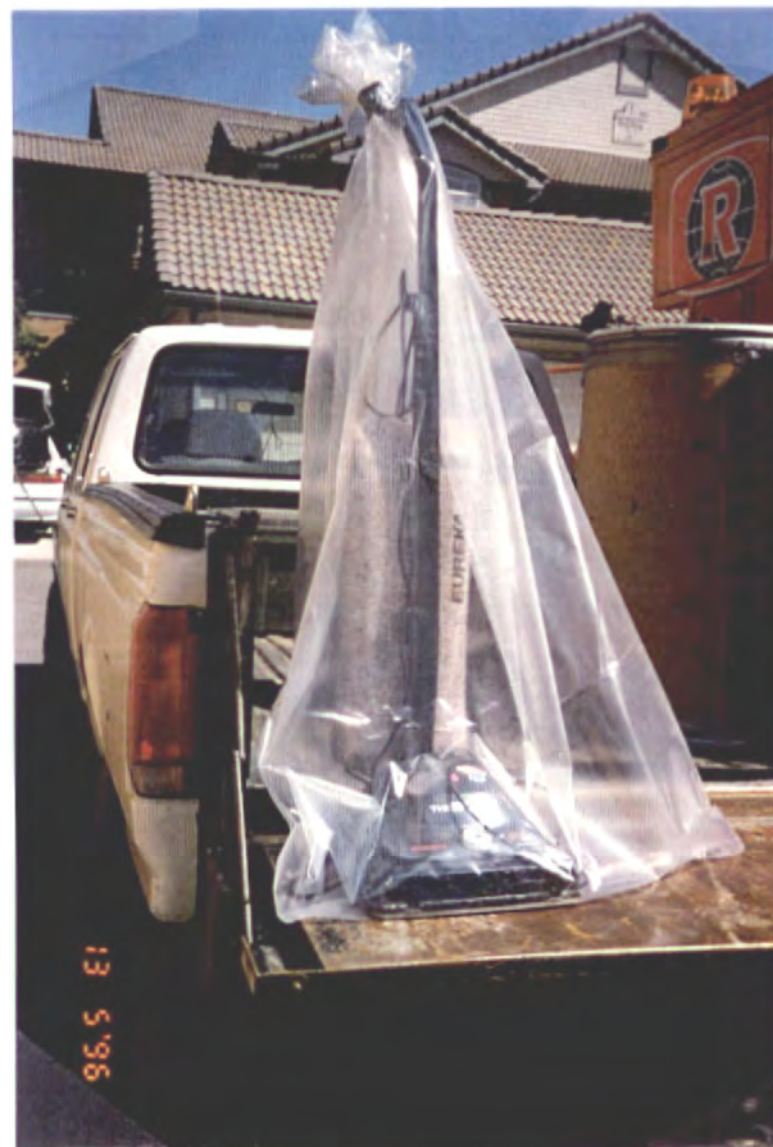
PHOTO 22

Vacuum cleaner to be disposed of. Mercury vapor concentrations were too high for residents to keep.
